HISTORIC STRUCTURE REPORT

Architectural Data Section

LINDENWALD

MARTIN VAN BUREN NATIONAL HISTORIC SITE

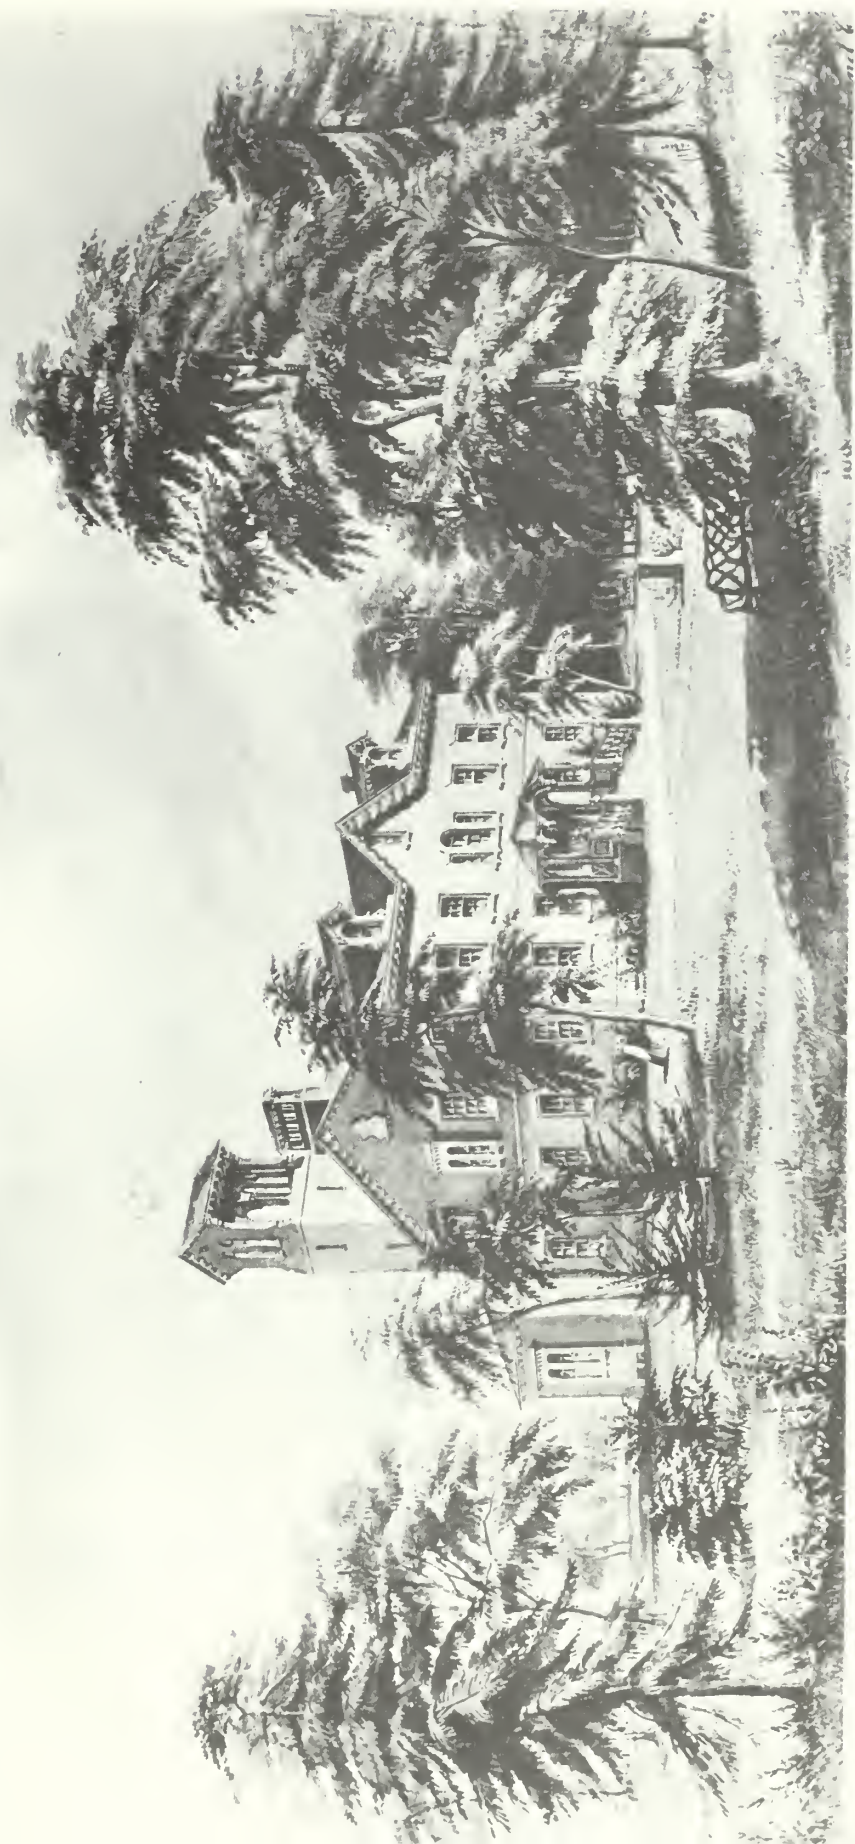
HP5. Lindenwald, ca. 1890-1900. This photograph of the south and east sides is dated ca. 1890-1900 on the basis of recollections of the donor, Hazel Whitbeck, a long-time resident in the vicinity. The following details should be noted:

The southeast corner of the foundation appears to have been repointed.

Visible lawn furniture consists of a cast iron-bench, a rustic chair, a tripod trellis, and a hitching post.

The small tree in the foreground (directly in front of the trellis) is considerably smaller here than in HP6.

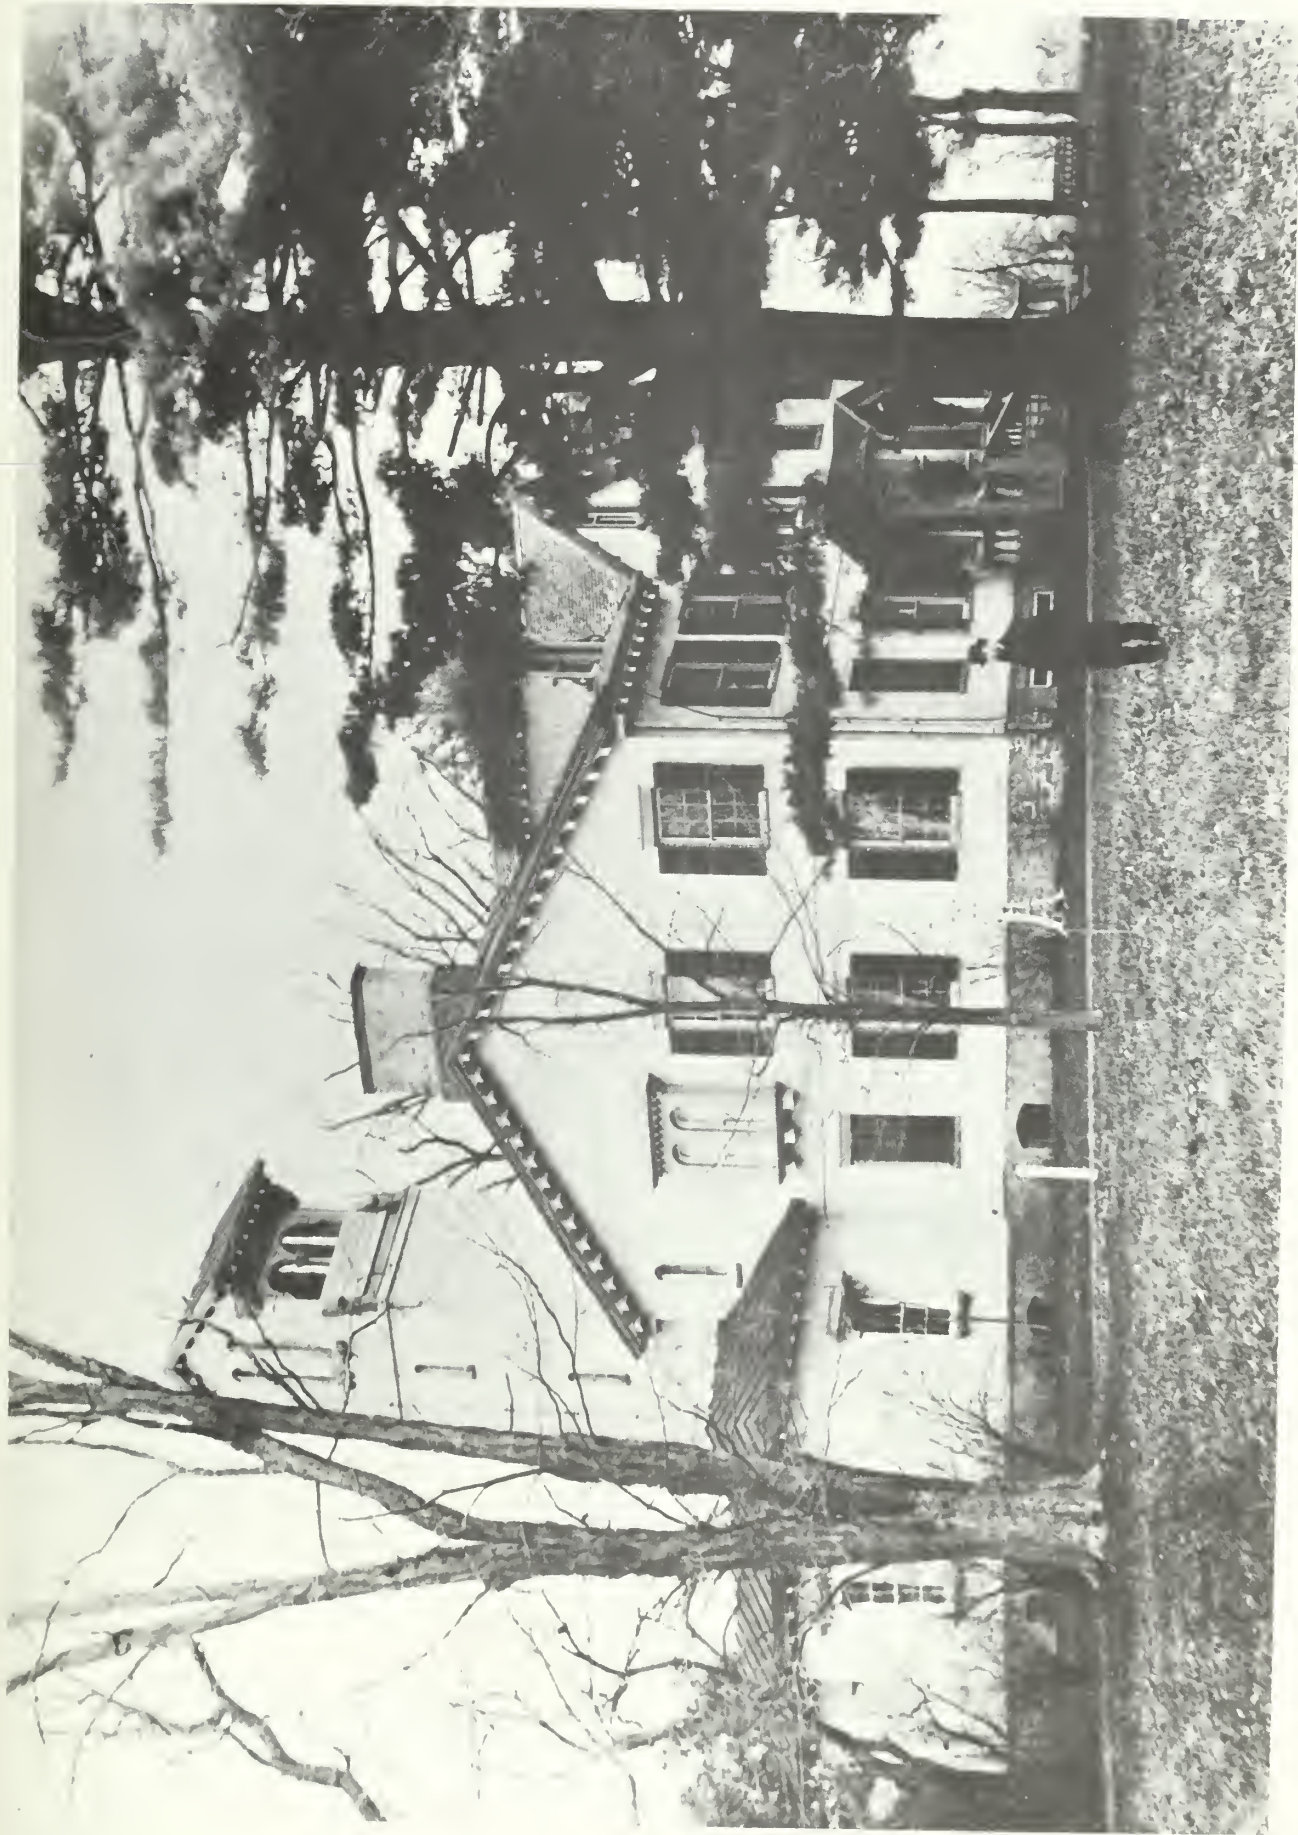
HP6. Lindenwald, ca. 1900. The date of this photograph is approximate because it is based on the growth of the small tree in the foreground compared to its size in HP5. The following details should be noted:

The dormer sill return is missing.

A rustic chair on the front porch, a glider, and a hitching post constitute the visible items of lawn furniture. The tripod trellis seen in HP5 may be hidden behind the small tree in the foreground.

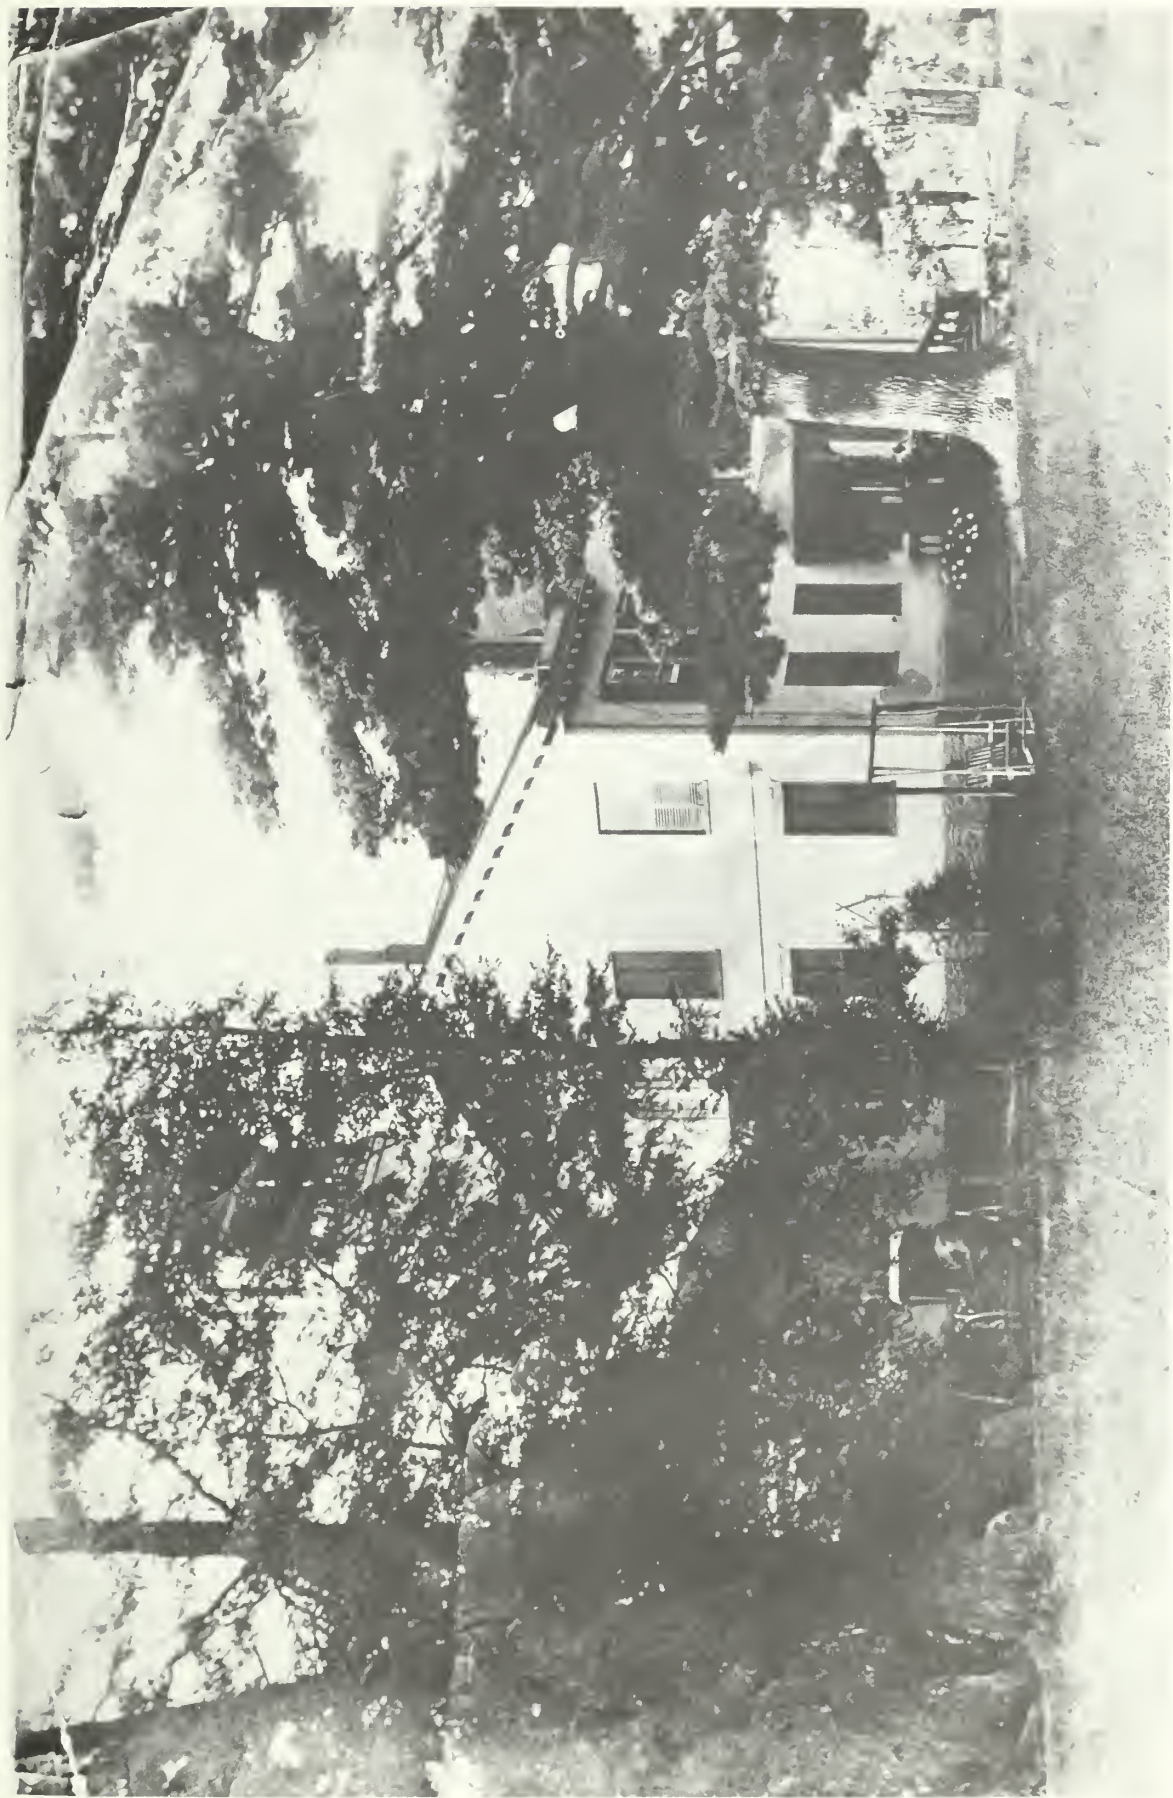
HP9. Lindenwald, ca. 1910-1917. The assigned date is based on similarities with HP8. The following details are noteworthy:

The foundation, window frames, shutters, and front porch seem to be painted a dark tone. The bricks and cornice are painted a lighter tone.

There are ferns planted along the north foundation wall.

There are two rustic chairs on the porch and a cast-iron bench under the north pine tree.

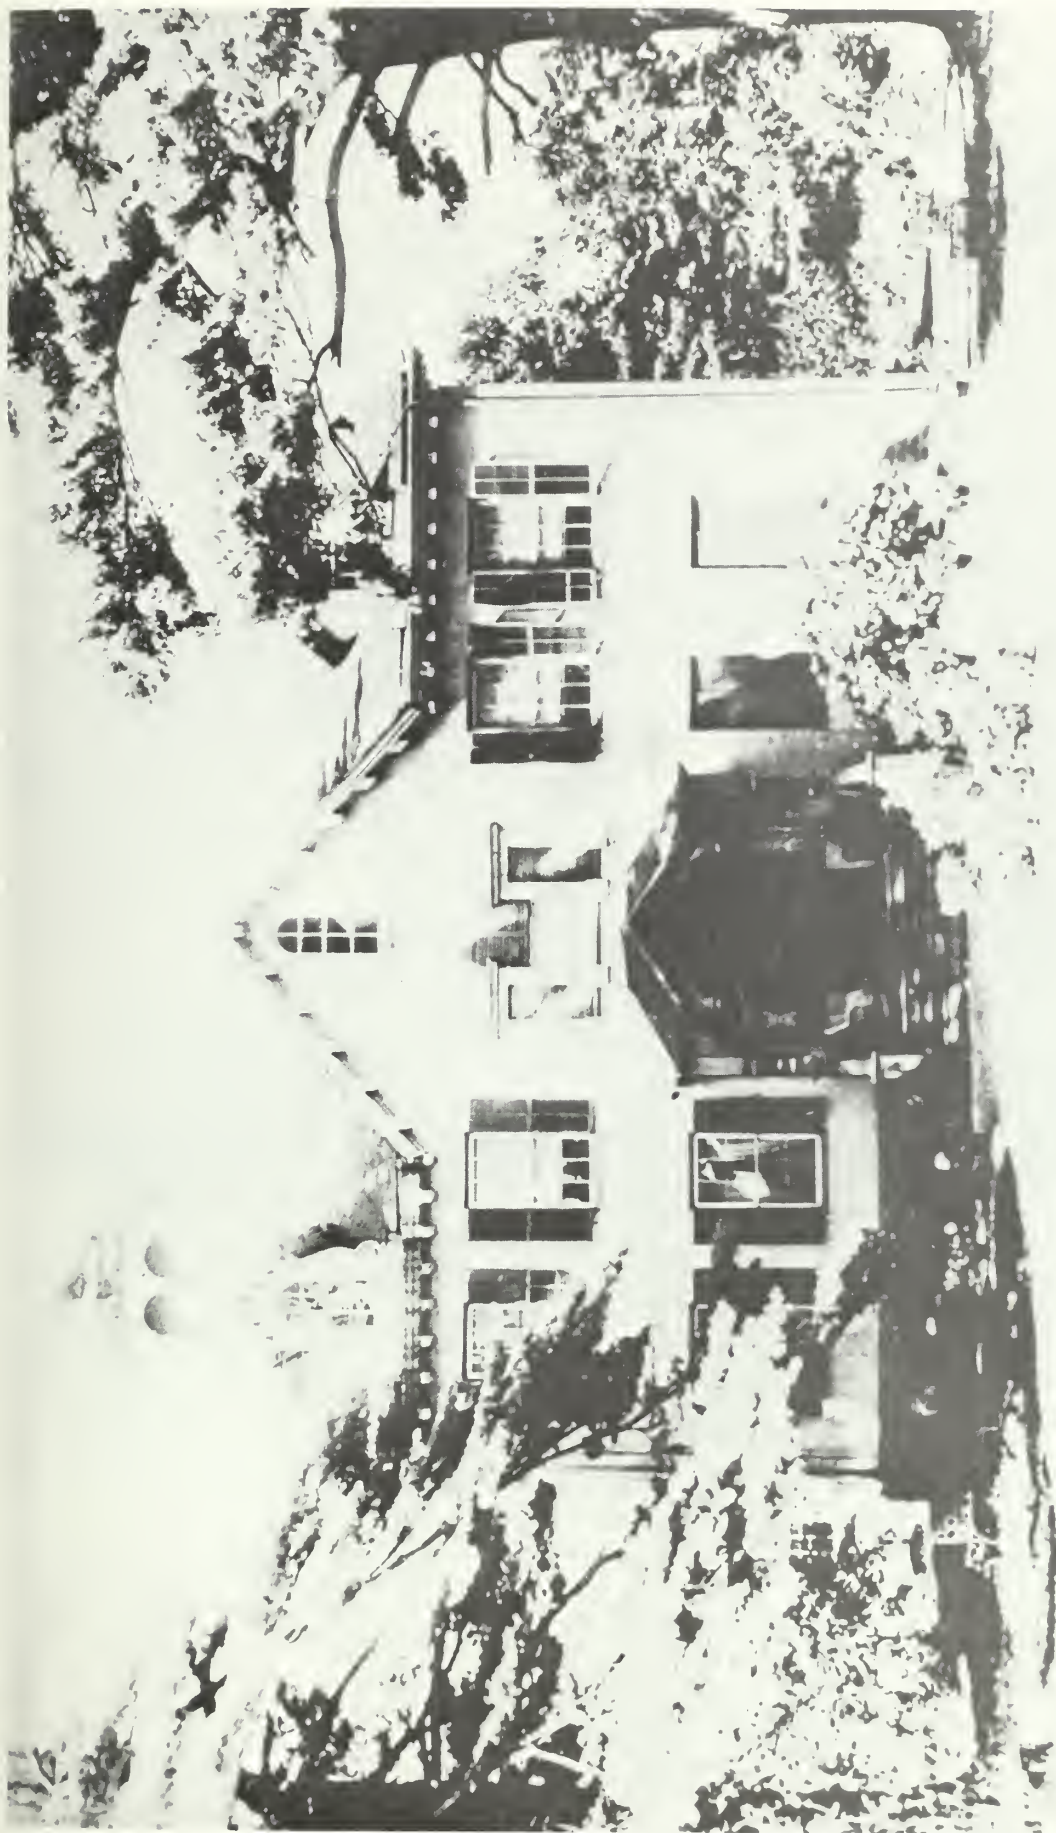
HP12. Mrs. Bascom Birney at Lindenwald, after 1917. This photograph was probably taken after the Birneys' acquisition of Lindenwald in 1917. The following details should be noted:

The foundation and trim appear to be painted a dark tone. Brickwork has been painted a light tone but is now quite weathered. Window frames are painted a lighter color.

The replacement cornice on the door pediment is in place.

The downspout appears to be a replacement consisting of lengths of stock corrugated pipe and a wooden board and trough to direct rainwater away from the foundation.

There is a grate over window well 011.

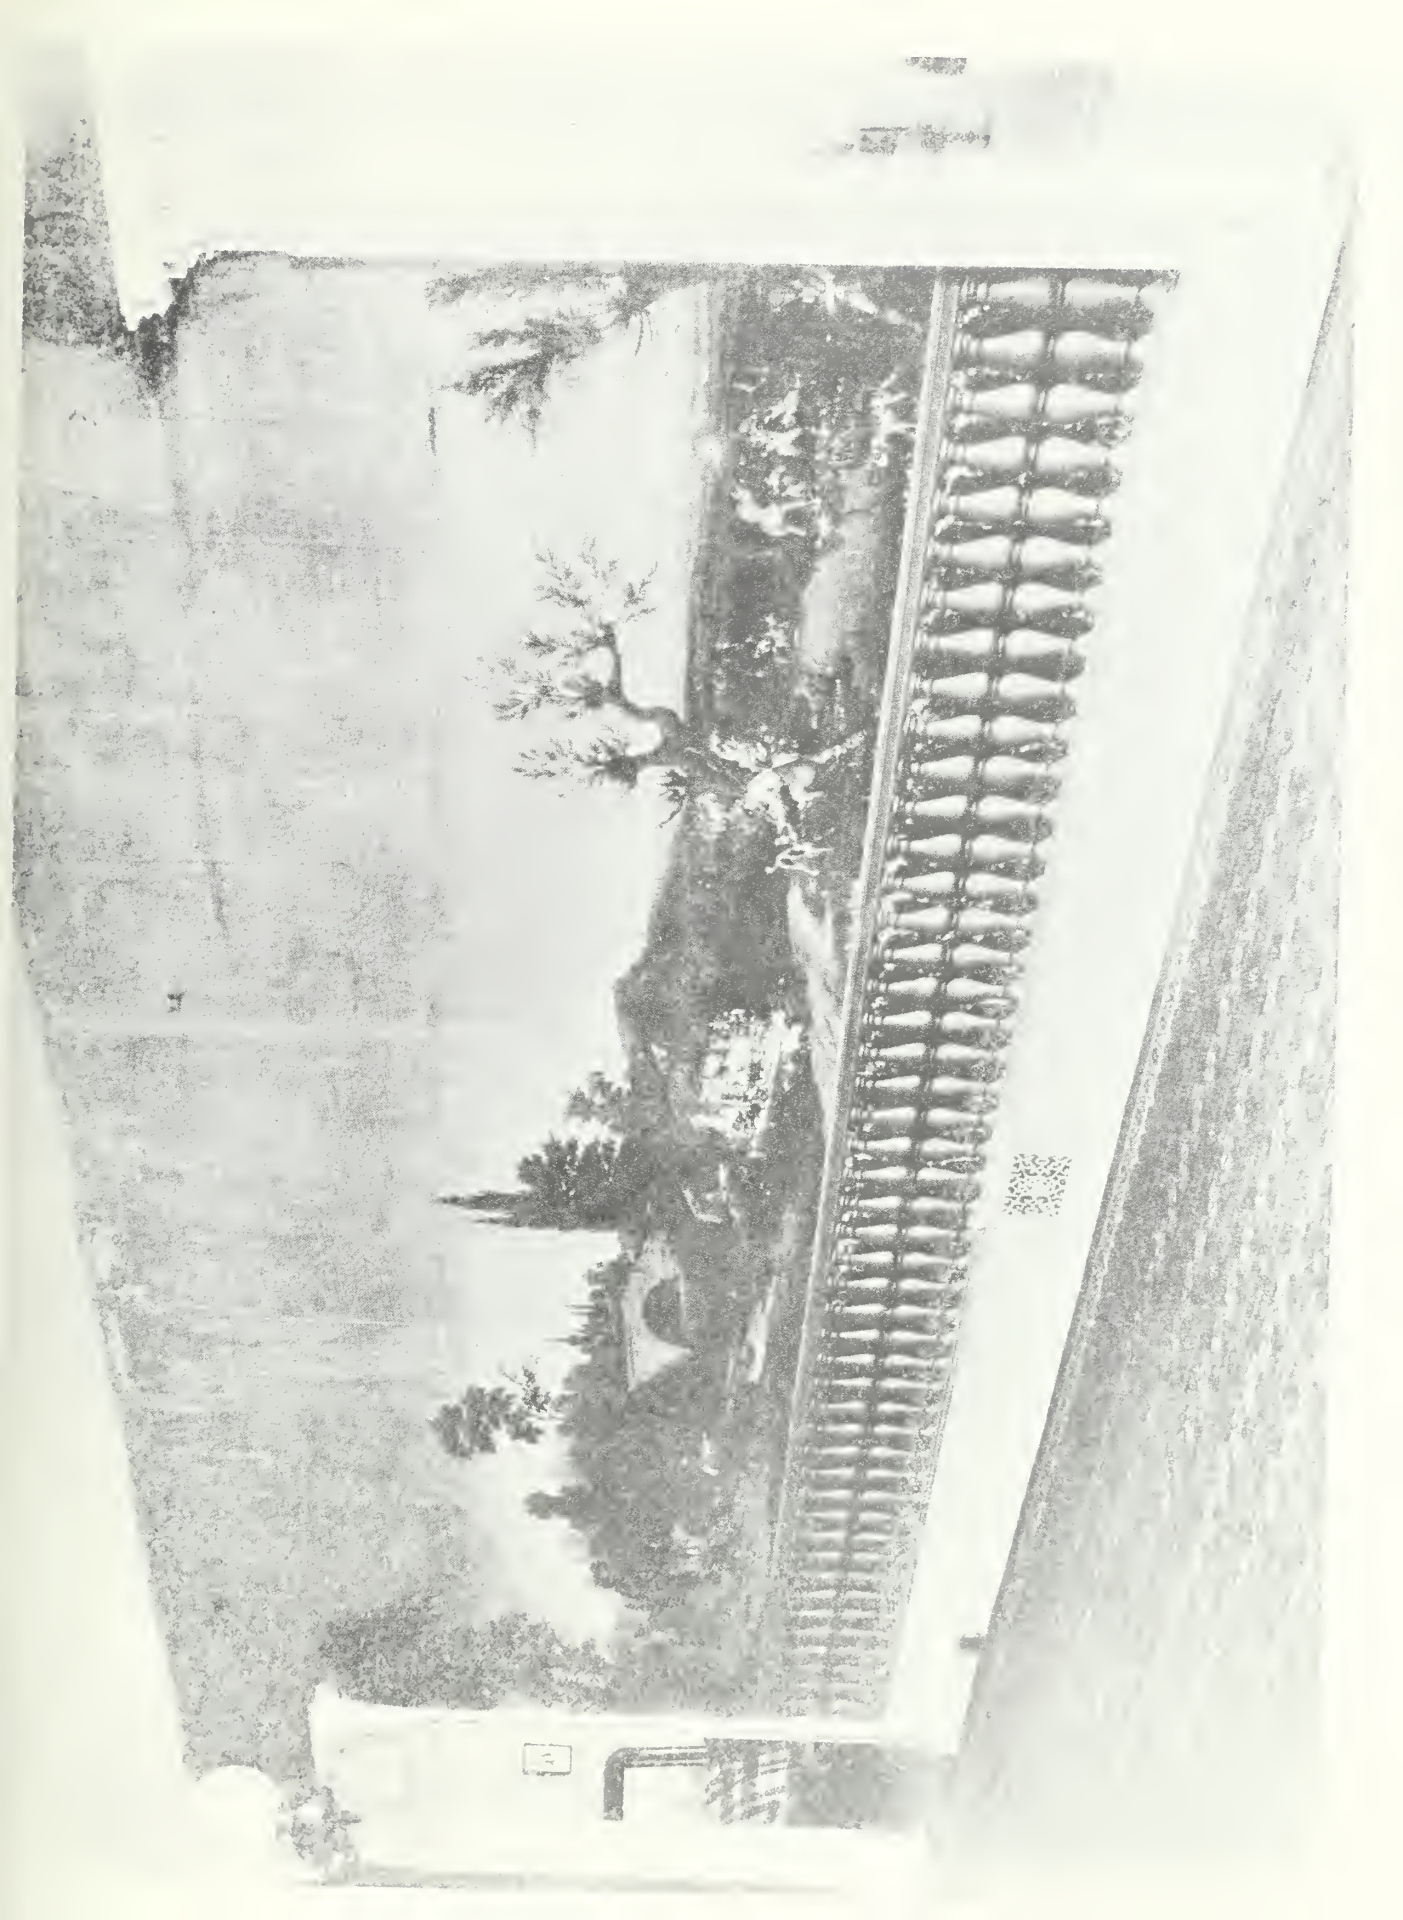
HP18. South and East Facades of Lindenwald, ca. 1917-1925. This photograph is considered to postdate 1917 because the lightning rods are missing from the front of the house and because roofing brackets and a plank are still attached to the roof (indicating that roofing work is still in progress). It is considered to predate 1925 because the tie rod is still in place on the front porch, and shutters are still in place on the Venetian window (see HP22). This photograph was taken by Rowles Studios. The following details should be noted:

The return for the sill at the north dormer is missing.

Brickwork, oriel window, and cornice seem to be painted a light tone. Window frames, shutters, foundations, and front porch seem to be painted a dark tone. On the addition, window frames are a light tone and hoods and roof are a dark tone.

Bricks are loose in the flat arch over window 127.

Sheet-metal gutters have been added to the south dormer.

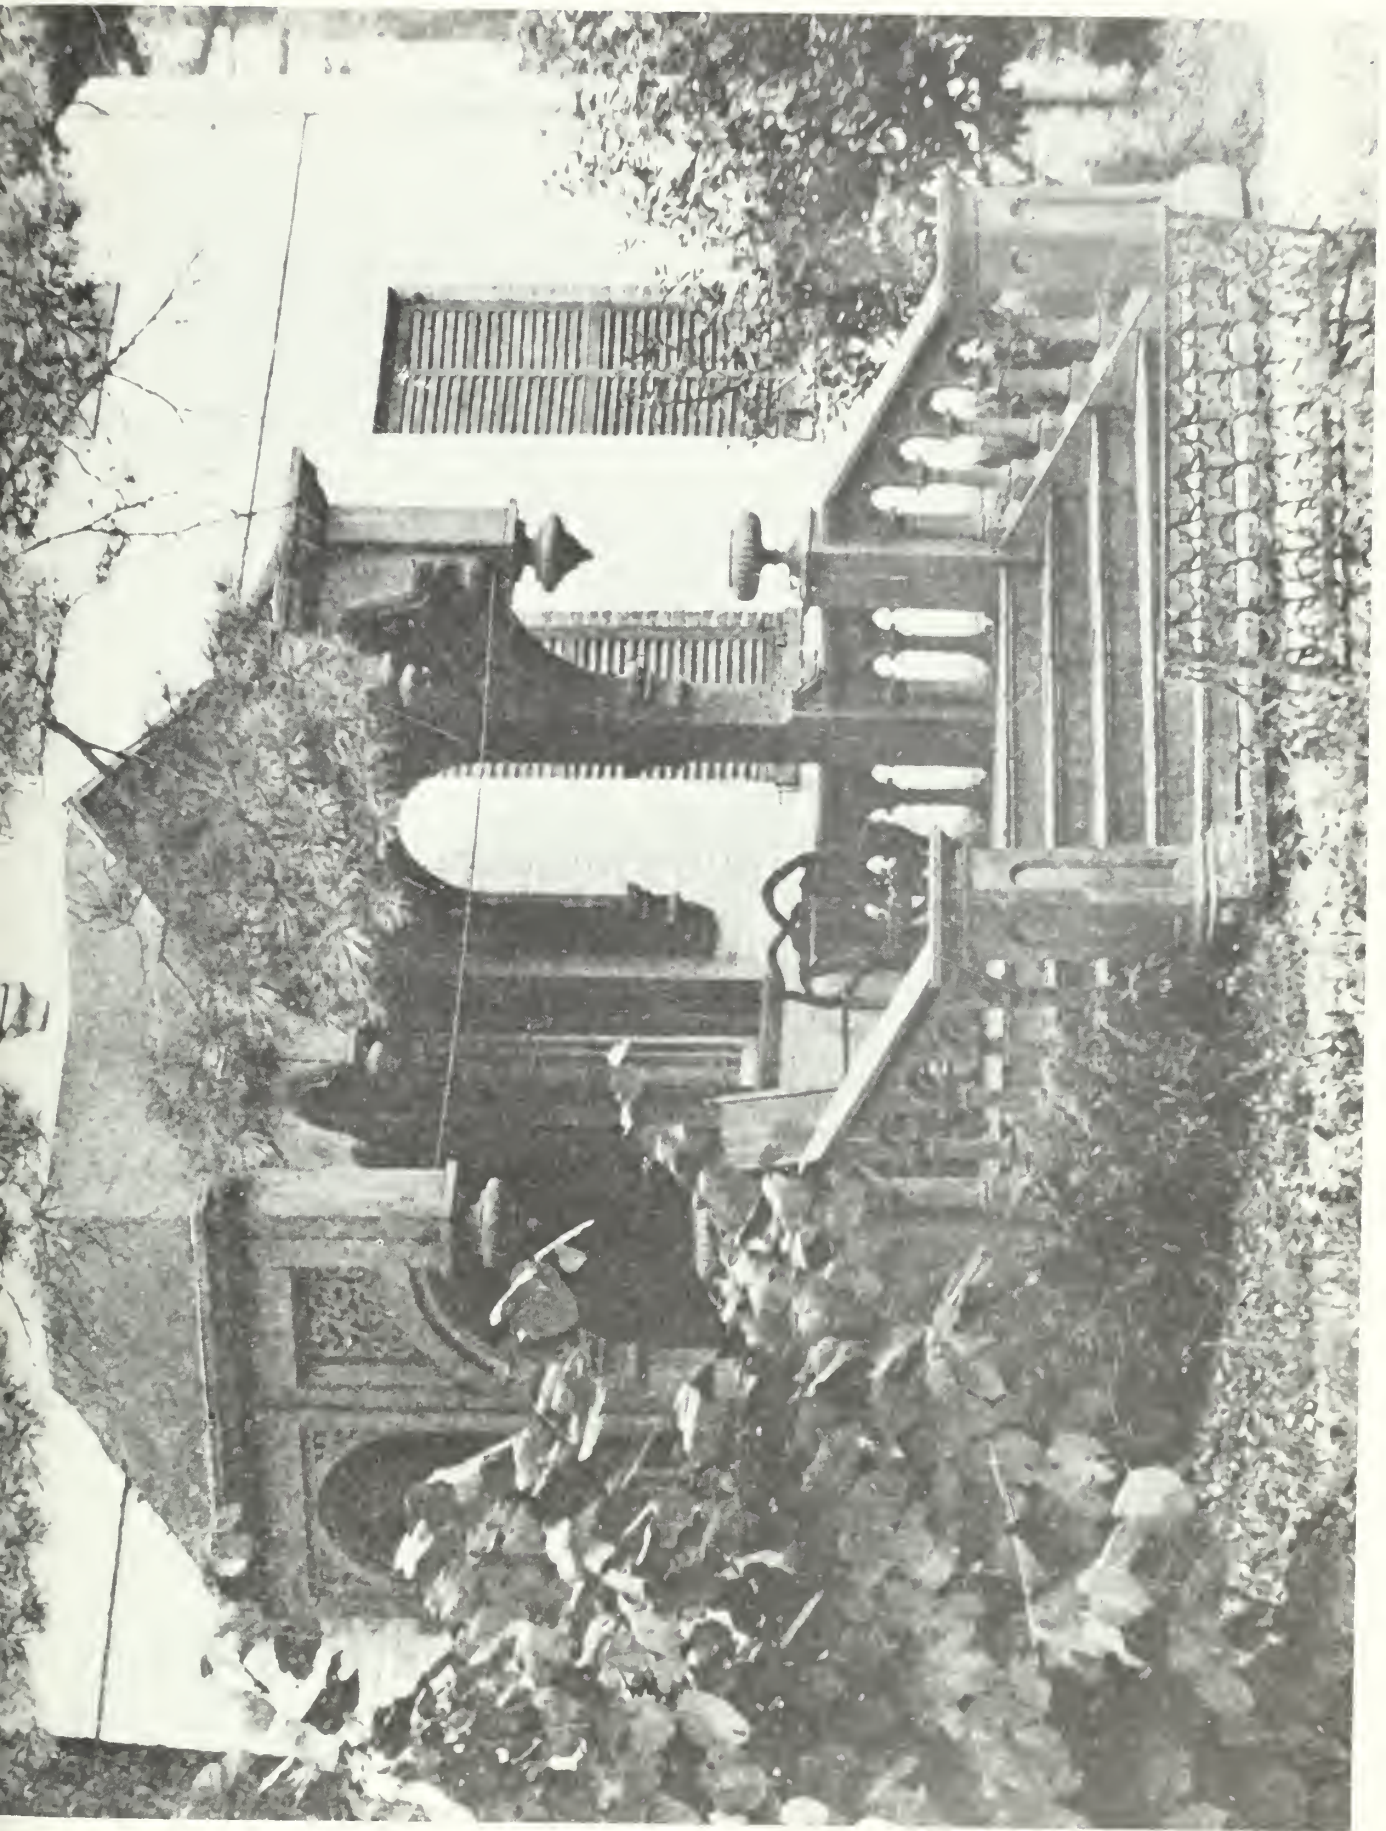
HP20. Lindenwald, ca. 1917-1925. Because of the absence of front lightning rods and the presence of roofing brackets and planks, the tie rod on the front porch, and the shutters on the Venetian window, this photograph is associated with HP18 and assigned the same range of dates. The following details should be noted:

The front board of the sill box under the south dormer is missing.

The brickwork, cornice, and sash seem to be painted a lighter tone. Window frames, foundation, and front porch are painted a darker tone. Shutters seem to be painted an even darker tone.

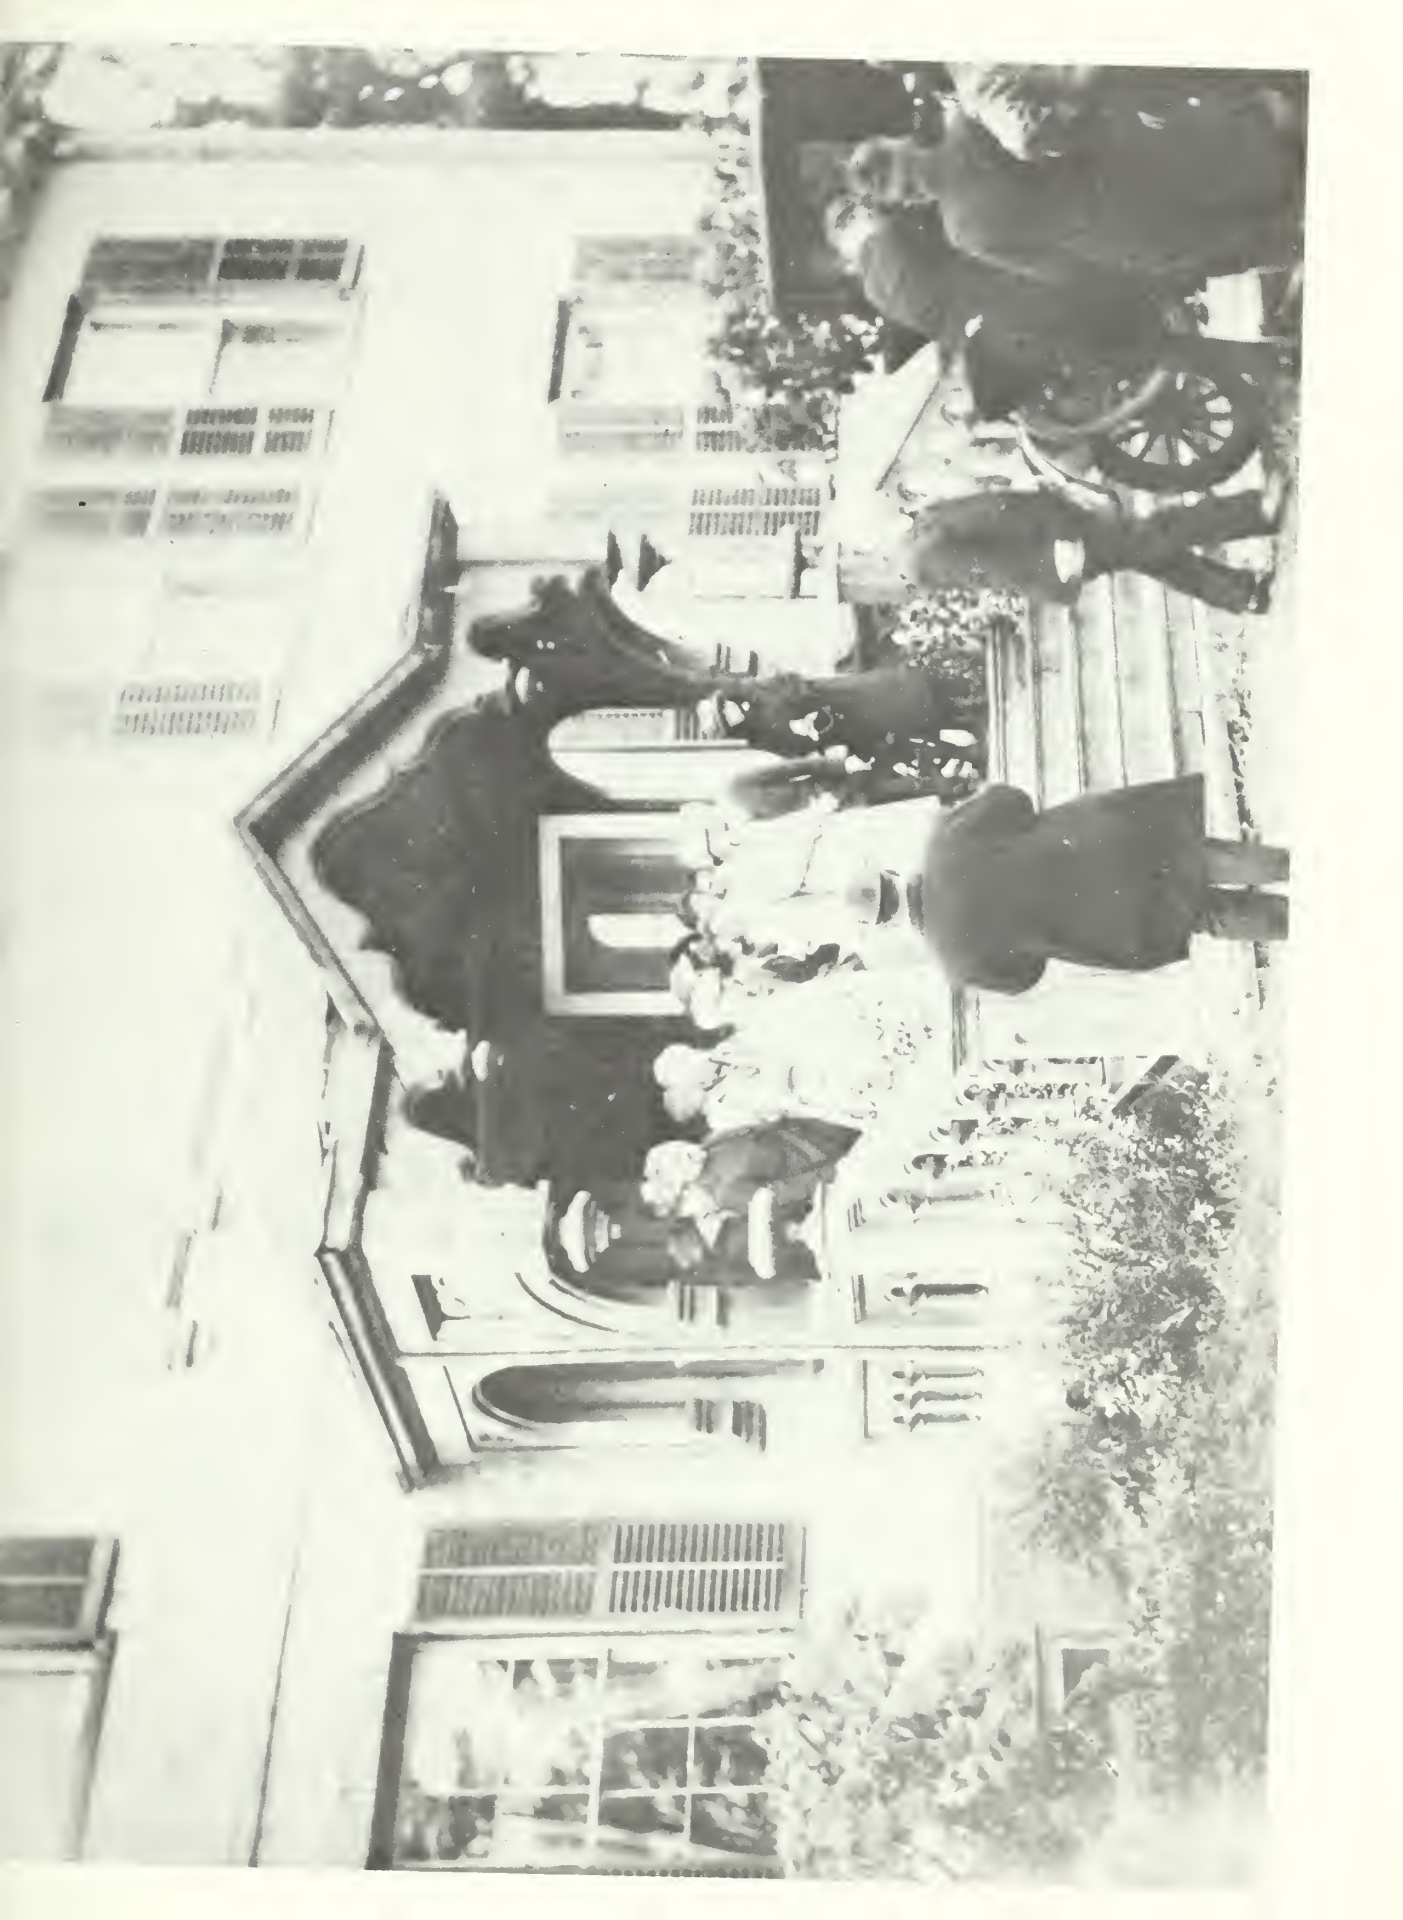
HP23. South and East Sides of Lindenwald, 1936. This photograph was taken by Melvin Weig, National Park Service historian, on August 3, 1936. This date is documented in the captions of all the photographs in his report "'Lindenwald,' the President Martin Van Buren Homestead, near Kinderhook, New York" dated November 3, 1936. The following details should be noted:

Some bricks are missing from the cap of the south chimney.

The light paint on the brickwork is very weathered and most brick courses on the south elevation can be seen. Sash has also been painted a light tone, but now the cornice appears to be a dark tone. Foundations, window frames, and the front porch are painted a dark tone. Shutters appear to be painted an even darker tone.

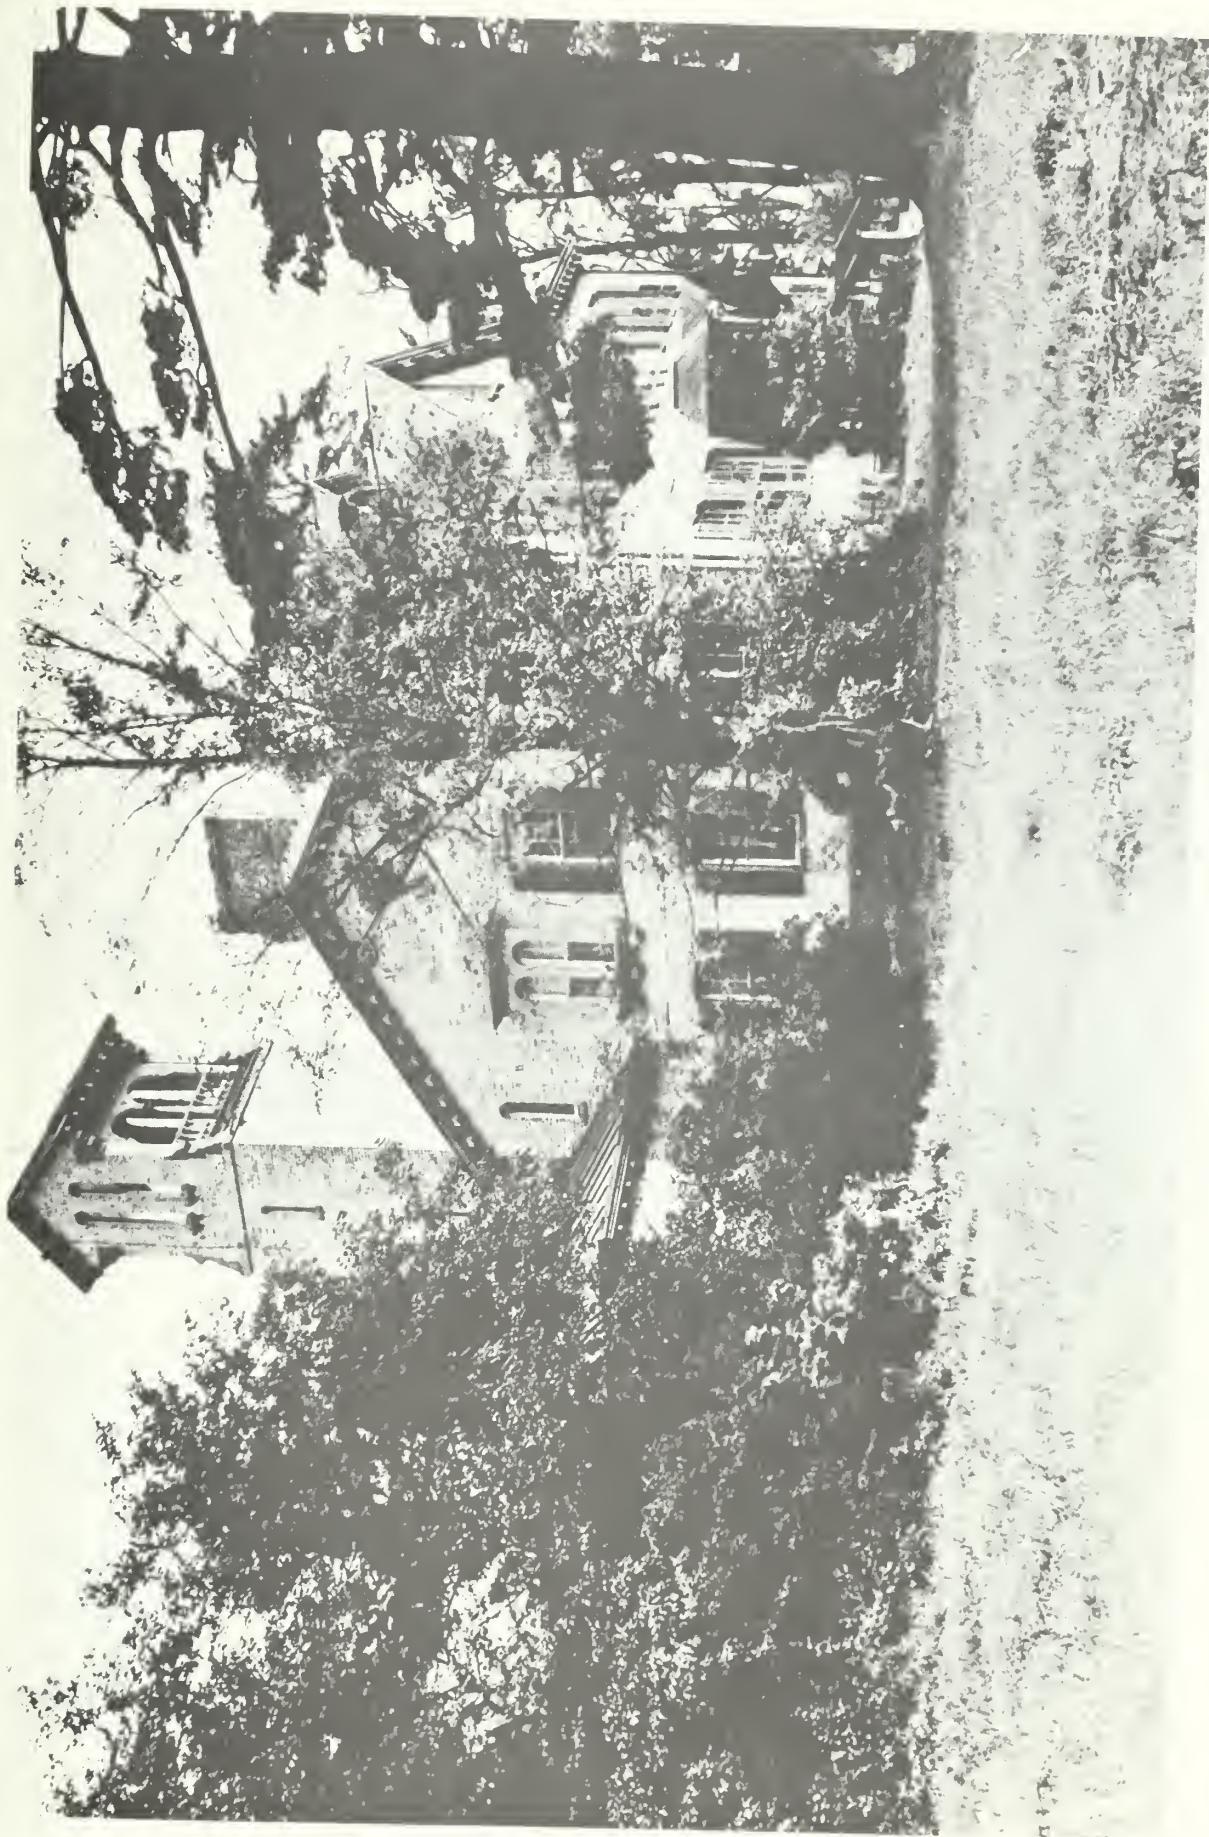
HP24. Lindenwald, East Elevation, 1936. This photograph was taken on August 3, 1936, by Melvin Weig. This date is also documented in his report, "'Lindenwald,' the President Martin Van Buren Homestead, near Kinderhook, New York." The following details should be noted:

Some bricks are missing from the cap of the south chimney.

The light paint on the brickwork is very weathered, and most brick courses on the east elevation are discernible. Sash has also been painted a light tone, but now the cornice appears to be a dark tone. Foundations, window frames, and the front porch are painted a dark tone. Shutters appear to be painted an even darker tone.

A rainwater diverter is present on the east end of the north raking cornice.

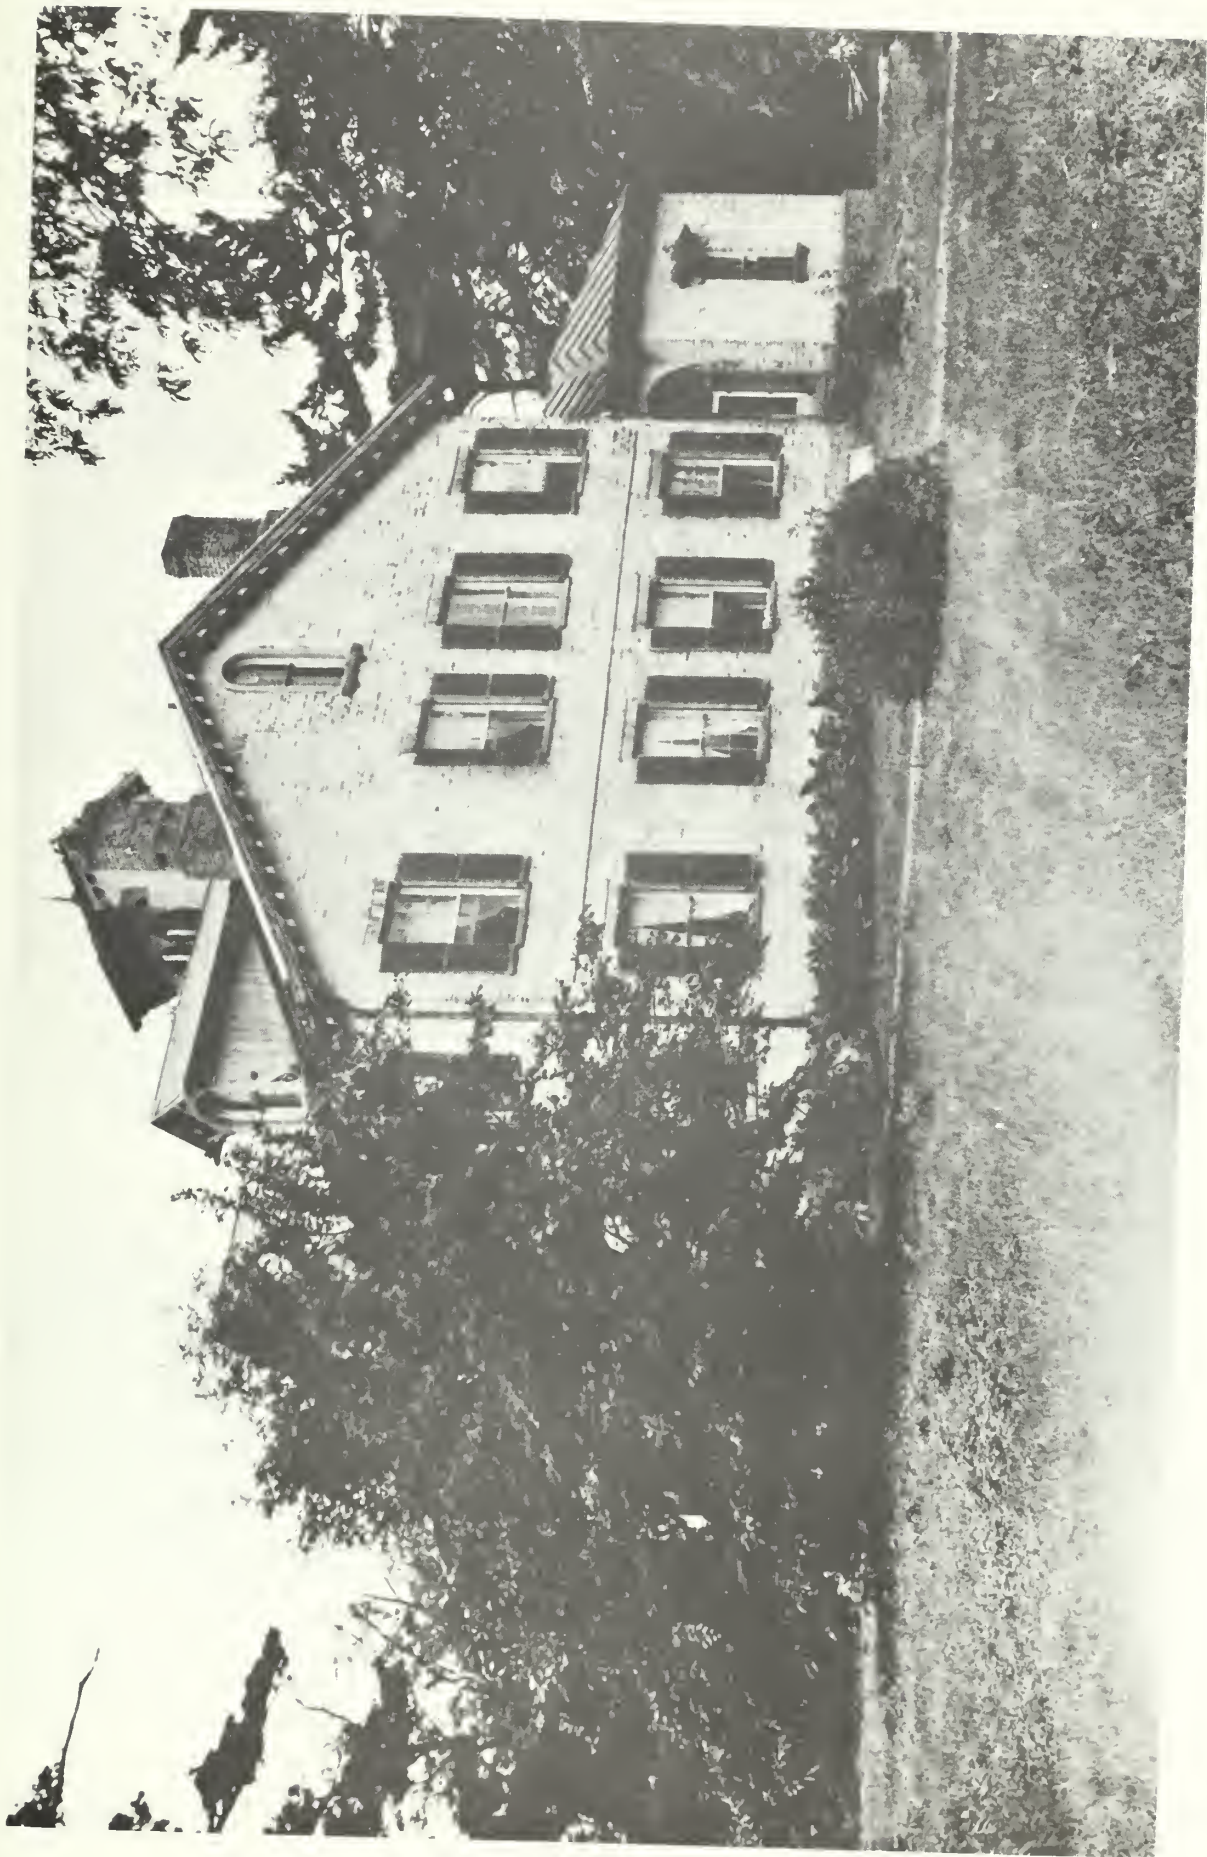
HP27. West End of the North Elevation of Lindenwald, 1936. This photograph was taken by Melvin Weig on August 3, 1936. The following details should be noted:

The belvedere windows are missing lights.

The lower section of the downspout is stock corrugated sheet metal (replacement).
